Church of St. James, Avebury, Wiltshire.

The church of St. James in the small village of Avebury is situated just outside one of the greatest stone circles in England. Avebury is about 6 miles west of Marlborough and a mile north of the Great West Road, itself formerly a Roman road. So wrote H.Taylor in volume one of his book "Anglo-Saxon Architecture".

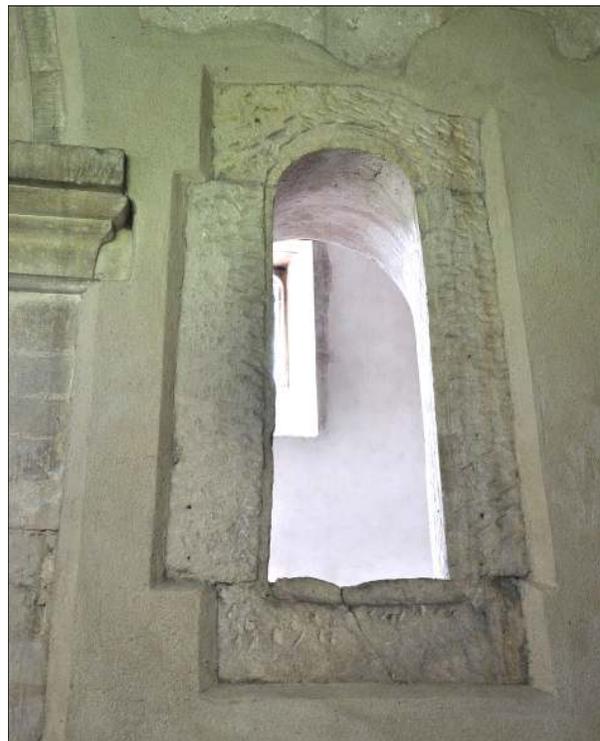
1. External face of north round-headed window .
2. The internal face of the same window.

The apertures of the upper circular windows are about 7 inches in diameter. They have their centre line about 23ft (i) above the present floor. The two lower round-headed windows have apertures about 4 ft tall externally, tapering from 1ft 4in at the sill to 1ft 3in at the springing of the heads. Their sills are about 9ft above the present floor, and internally their apertures are splayed to be about 2ft 6in wide and 6ft tall.

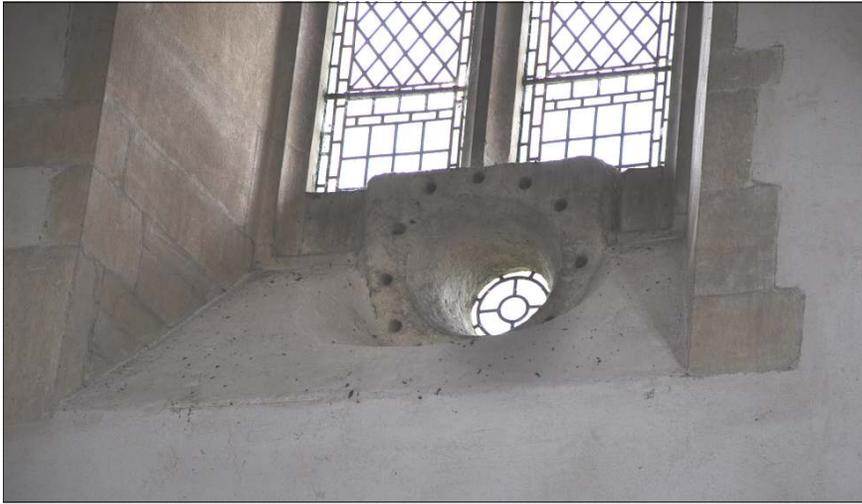
3. The westernmost circular window in the nave north wall.
4. The other remaining two circular windows.
5. A part of the bold string-course, at its western end, on the external face of the north wall (viewed from the north aisle). Note: this is virtually identical in size and section to that on the north wall of the tower at Wimborne Minster and which can be seen from inside the north transept, and also on both transepts at a lower level - see the relevant file on that particular church.
6. The NW quoin, which apart from one tall stone some 30 inches high, is of side-alternate construction. This photograph has been enhanced (sharpened) to distinguish the different stones.

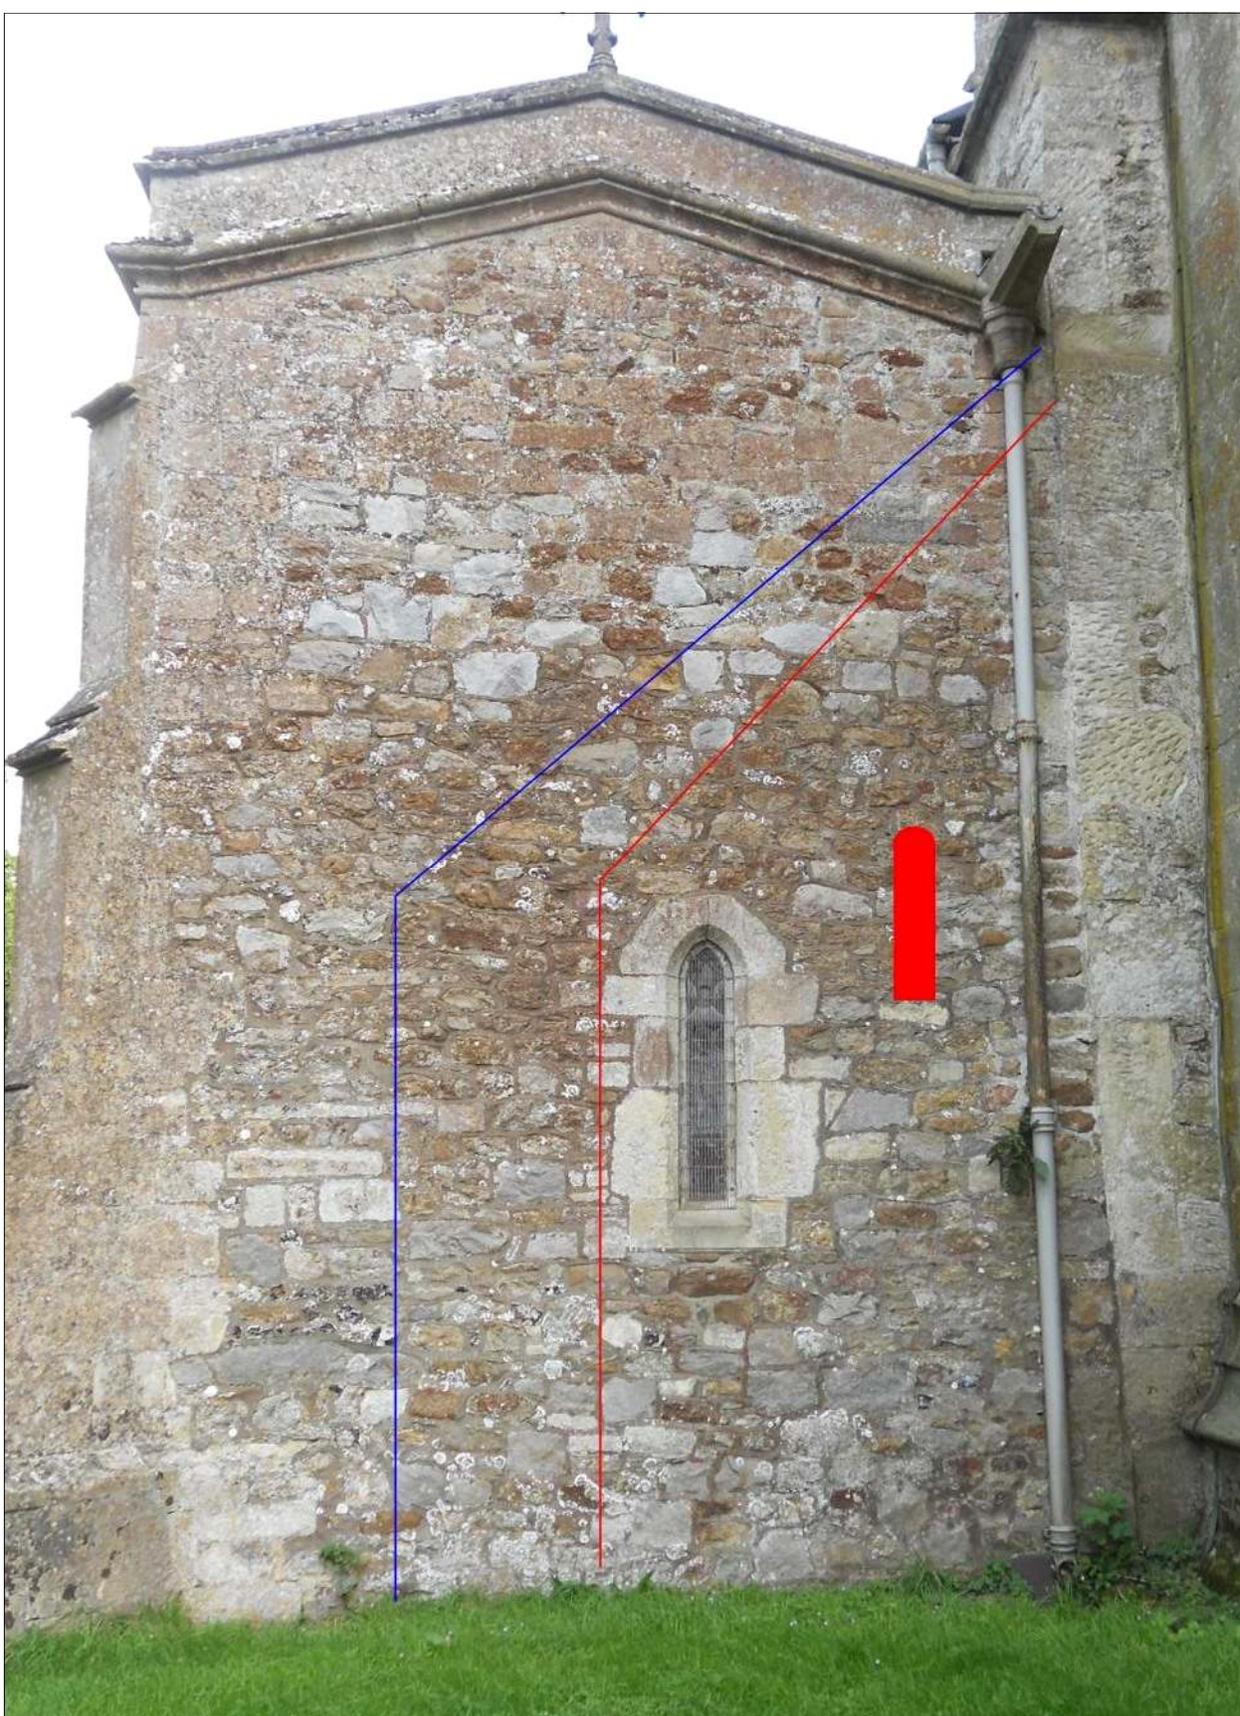
7. This picture is to show the progression of building of the three successive north aisles and how they sat against the NW quoin of the Anglo-Saxon nave. The red vertical line picks out the probable corner of the relatively narrow Norman aisle and also its roof line. The "red window" shows the probable site of the Norman window. The blue lines show the extent of its Early English successor. The EE window has survived in the west wall. In all medieval builds the Anglo-Saxon circular clerestory windows were allowed to remain and until the 19th century restoration when new windows were inserted but not without respecting the antiquity of the pre-conquest windows in the north wall of the nave.
