The church of St Martin, Canterbury.

When Augustine arrived in Kent in 597 he baptised king Ethelbert, who was married to Bertha, a Christian of the Frankish royal house. Bede records that on the east side of the city there lay a church dedicated to St. Martin, and built while the Romans were still in the island, where the Queen used to worship before the coming of Augustine. The nave is broad and low, in contrast to Minster-in-Sheppey, but is built of the same sort of material and constructed in a similarly rough manner, suggesting that it dates from the seventh or eighth century. The chancel foundations are overlain by that of this nave indicating the chancel is earlier. It is therefore quite likely that (the western half of) the chancel is Roman, but even if it was built for Bertha in the late sixth century, it still has the distinction of being the oldest standing Christian structure in the country. *Sources: E. Fernie & H. Taylor.*

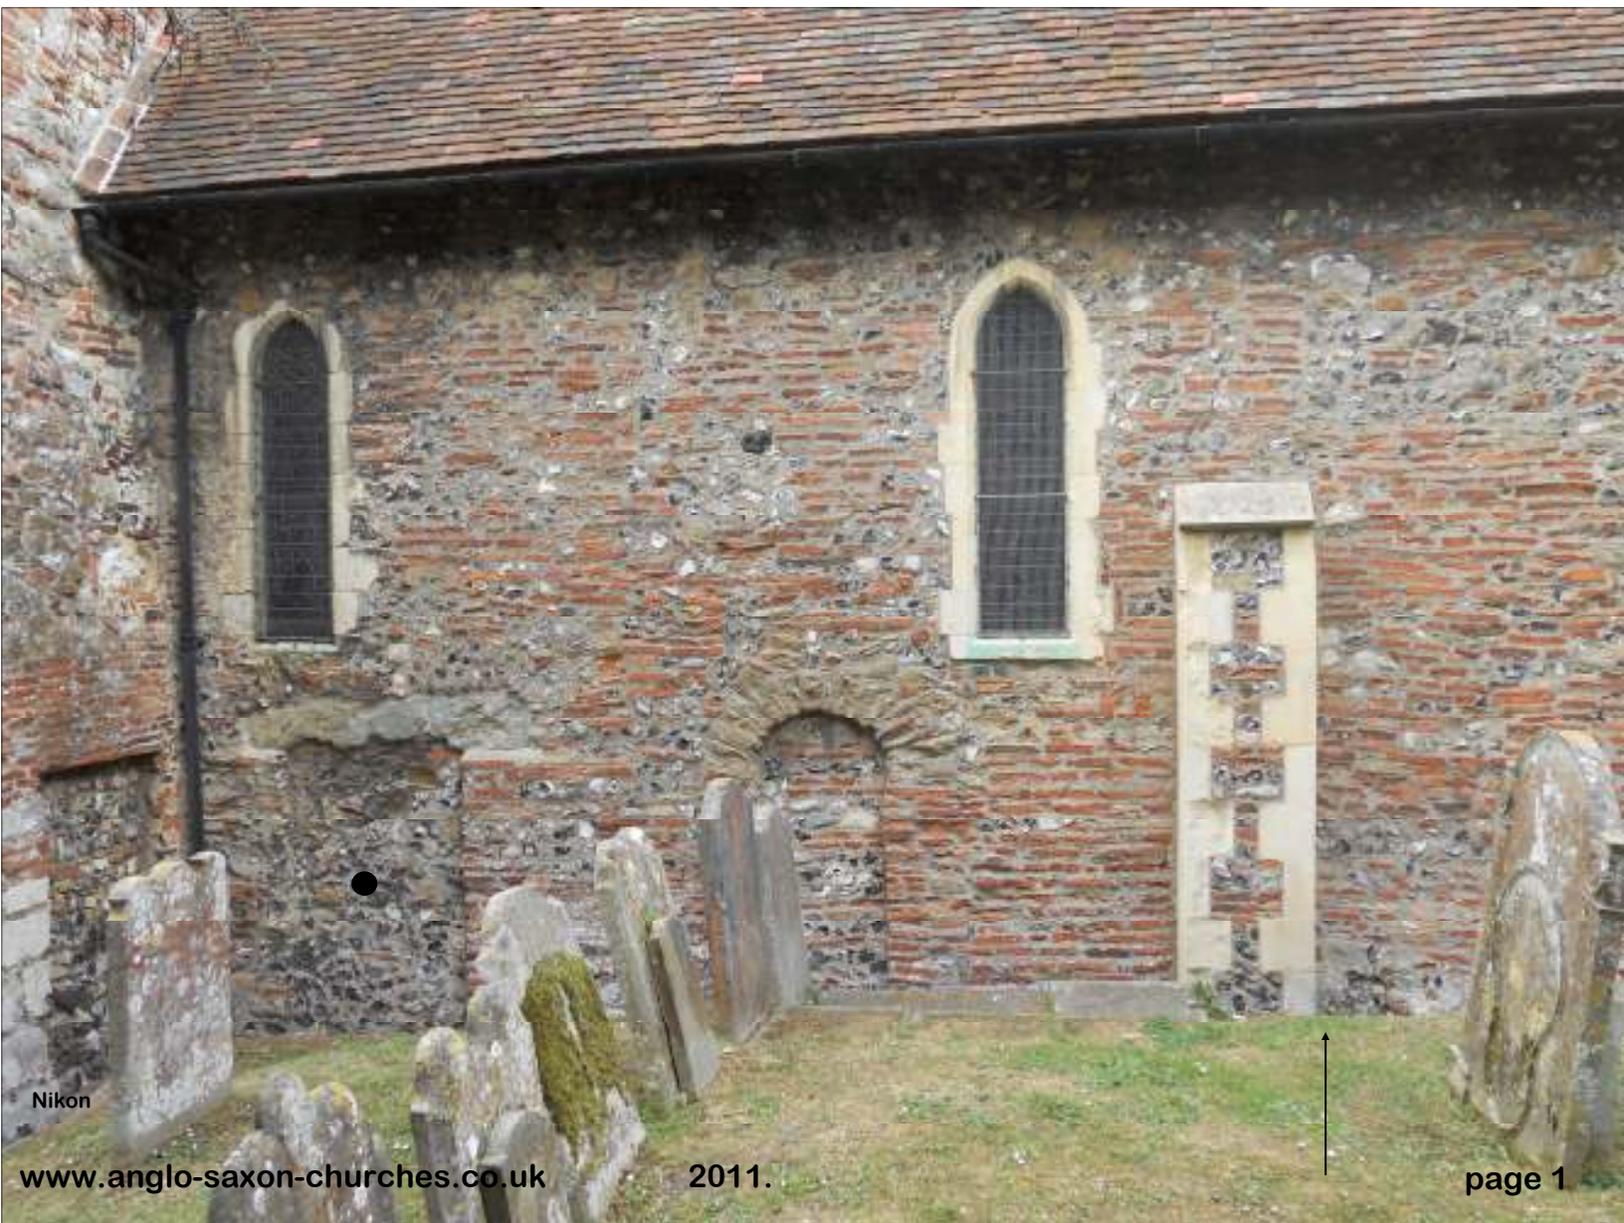
1. The western portion (half) of the south wall of the chancel. The later extension lies to the right. Part of the Anglo-Saxon nave is to the left just in picture. Taylor states that this western portion of the chancel once extended further west than it does at present, and this was the nave of the church referred to by Bede, in which queen Bertha worshipped. The later medieval extension of the chancel has swept away and overlays the original eastern end, and the present nave has destroyed the western portion of the old nave (now chancel). The square headed doorway which blocked (marked by black dot for clarity) originally led to a very small porticus, foundations were described by Taylor, and those of its west wall are overlain by that part of the existing nave. In the 1895 and 1900 excavations an area of *opus signinum* flooring was discovered besides the doorway, together with considerable parts of the side walls running south from the chancel. The blocked round-headed doorway to its east is of a later date and is an Anglo-Saxon insertion, possibly belonging to the same date as the nave. H. Taylor puts the eastern extent of the 'first' nave where I have placed the black arrow. See picture 5 on page 2 for a more easterly change of walling. We should bear in mind that during the time before the Conquest this building was subjected to many alterations.

4. The interior of the chancel, the south wall, a good run of walling here lies exposed. The blocked round-headed doorway centre picture with the square-headed blocked opening to the right. The black arrow corresponds to that on the exterior in picture 1 (previous page) and picture 5 also.

5. A view of the eastern 'half' of the south wall of the chancel, the common point with picture 1 on the previous page is the much later buttress with its white squared ashlar (black arrow). There is a further join, a change of wall type, which is indicated by the blue arrow, this being the final extension to the chancel.

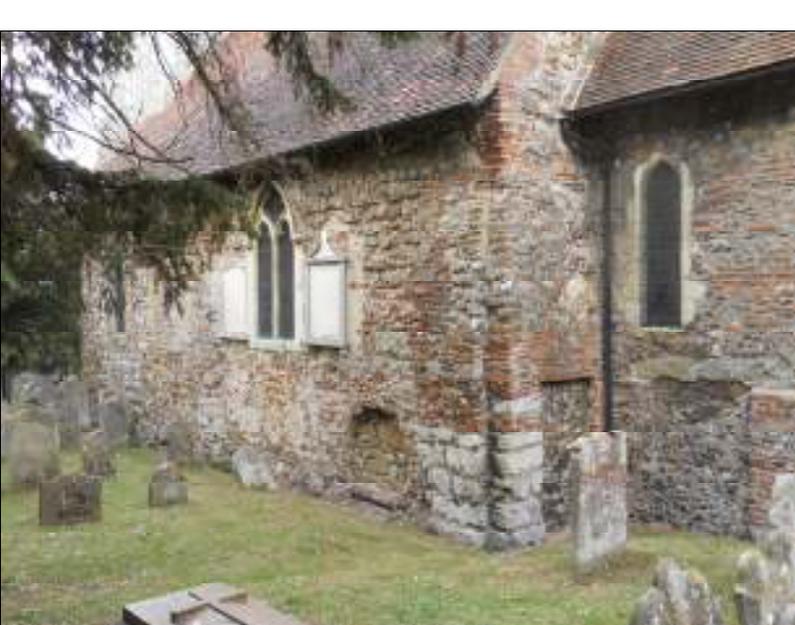
2. Seen to the right is the square headed doorway (previously described) in the chancel wall, and running to the left is the south wall of the nave. Comparing the make up of the nave walling with that of the chancel in picture 1 it is seen that the former is of a very different character, the Roman bricks are used not in regular courses as in the old chancel but rather with single bands of brick that are neither continuous across the walls nor even horizontally laid.

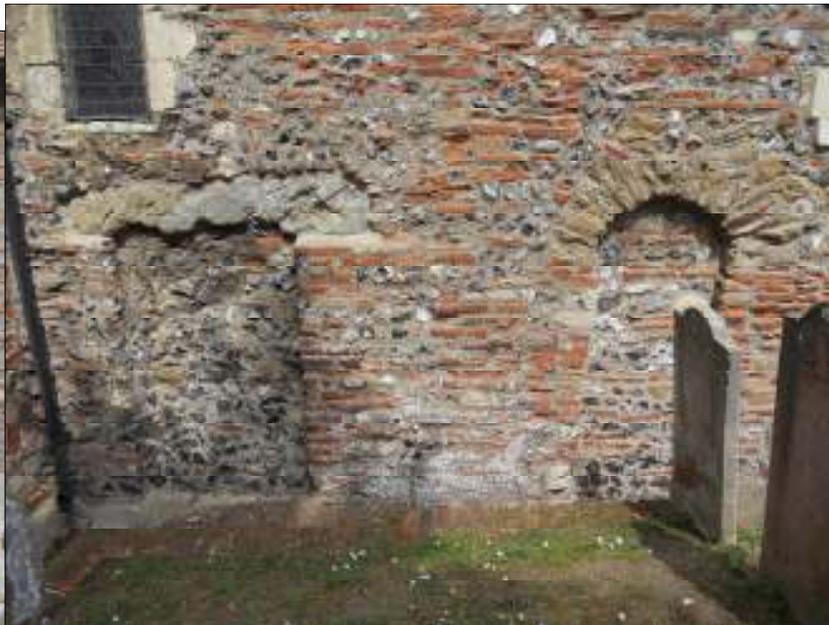
3. A closer view of both the openings in the south wall of the chancel.
