Church of St. Peter, Britford, Wilts.

Taylor's account of this church runs to a good two pages, but visible remains condense down to two side arches which originally led to their individual porticus, or side chapel, parts of the south doorway (much restored), and parts of the walls. Having been reopened in the restoration of 1873 the two arches were provided with small annexes into which they now open. Rickman saw the (then) blocked arches and dated them as Anglo-Saxon. Taylor puts a date of 800-950. Today there remains part of the fabric of the nave and parts of the east walls of the porticus embedded in the later transepts. The south porch was built to protect the original pre-conquest nave doorway which was reopened; it is however much altered.

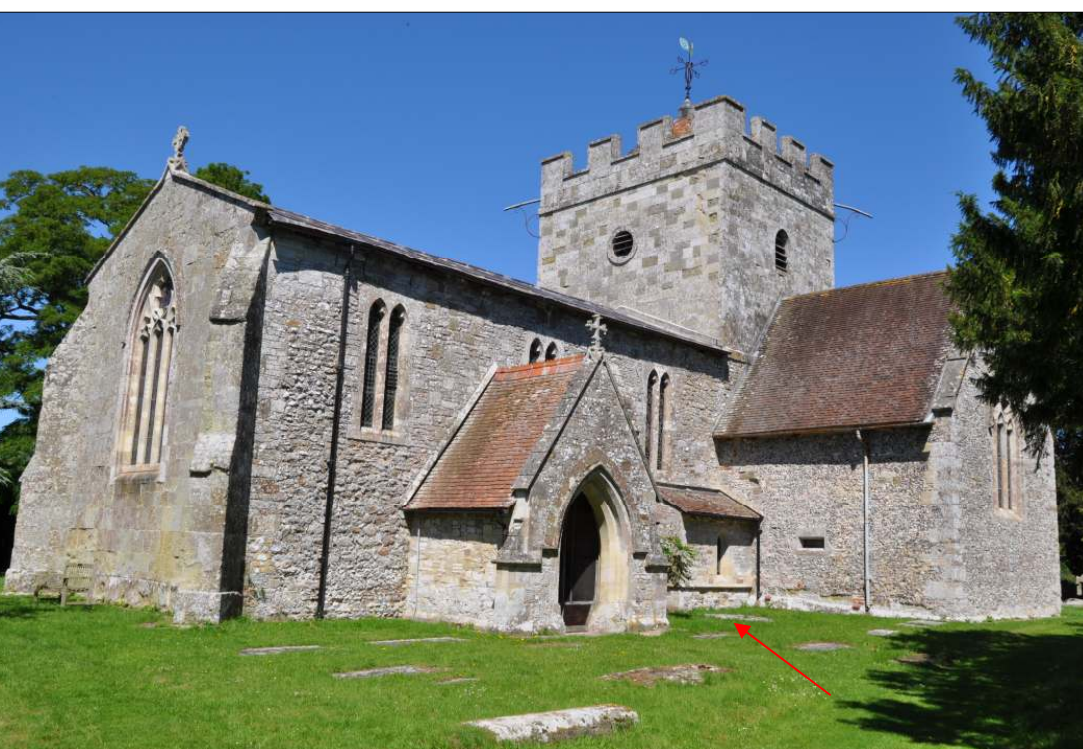
are not numbered. The first picture is of the church from the SW and it shows (red arrow) the south annex built to protect the opened up south archway to its 'lost' porticus. The nave west wall is a medieval, or later, possibly Georgian rebuild with a distinctive plinth which seems to indicate a date between 1720 and 1810.

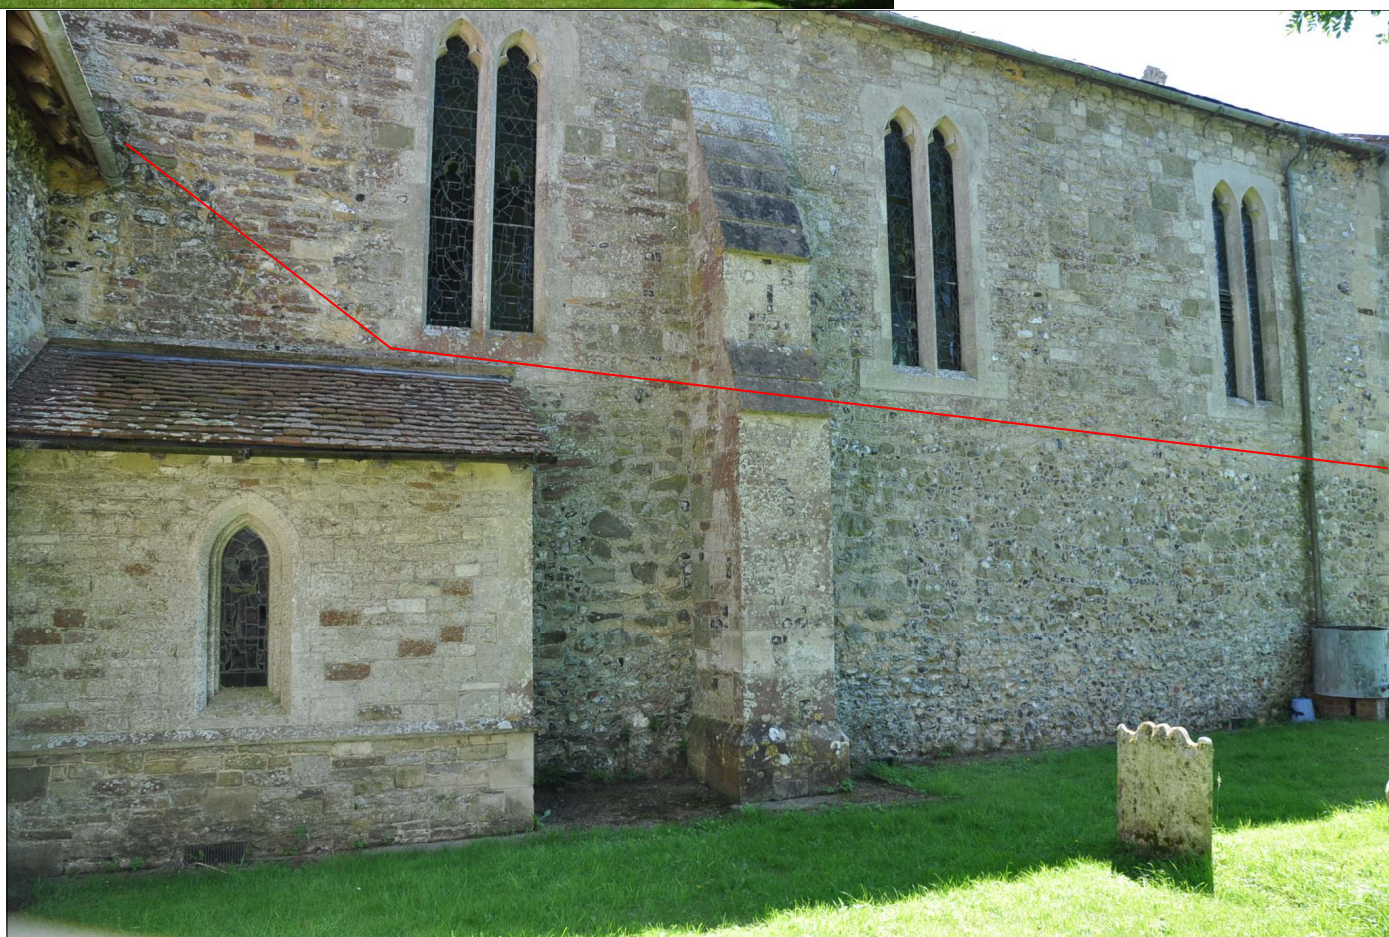
The lower picture is taken from the north and shows the nave wall with the annex (to the left) sheltering the north archway. It can be seen that the walling above the red line is of a completely different makeup to the Anglo-Saxon walling below. Unfortunately this means there are no traces of any pre-conquest windows in the fabric, and the medieval tower and chancel have swept away every trace of any older work. The tower above eave level appears to be a Georgian rebuild.

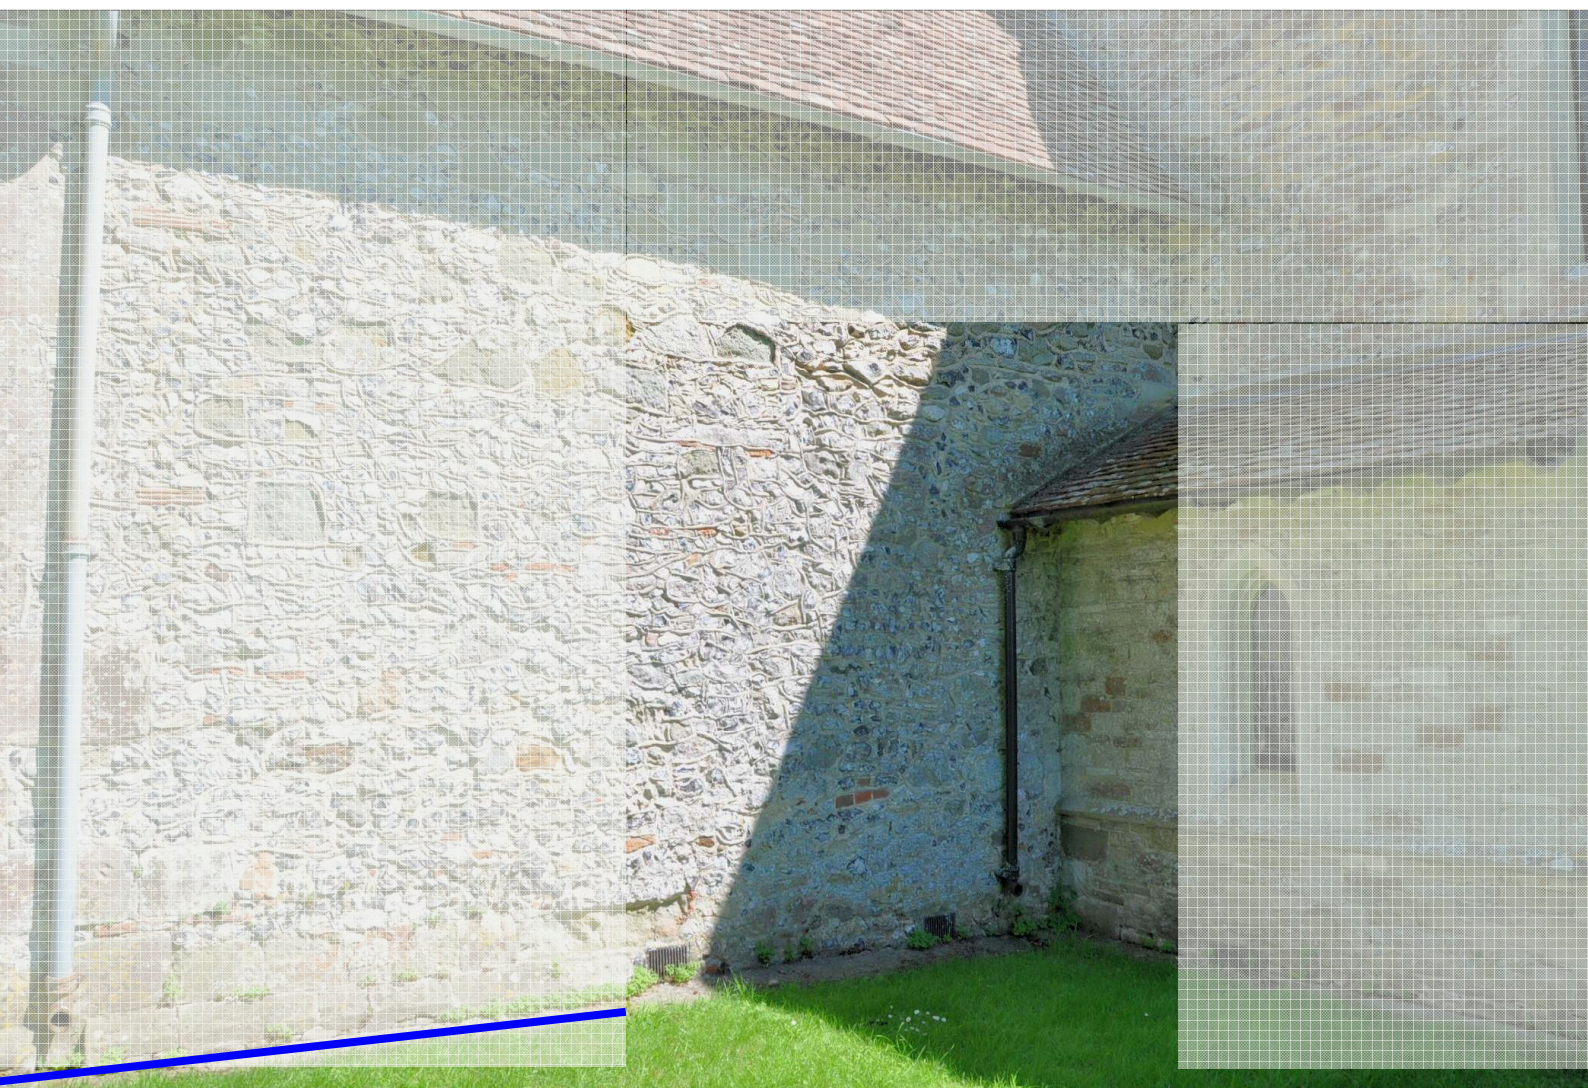
This shows the west wall of the north transept and part of the annexe built to shelter the north archway. I have reproduced it to fill the width of the page since the transept wall importantly contains original Anglo-Saxon walling, and which was the east wall of the north porticus. The medieval walling I have partly obscured so that the un-obscured walling is that belonging to the porticus. The blue line indicates the extent of the medieval plinth belonging to the walling which was extended northward when the transept was built.

H.Taylor, in volume I of his "Anglo-Saxon Architecture" (pages 105 to 108) gives the dimensions of the north porticus as 8 feet 9 inches from east to west internally and 10 ft north to south and with walls about the same thickness as the nave (2ft 5in). Nave dimensions are, internally from west wall to medieval west arch of the tower, 44ft 4in x 20ft 6in. The two archway dimensions are given height to crown, and width between jambs. South arch h 7ft 8in and w 5ft 7in. The north arch h 7ft 11in x w 5ft 10in.

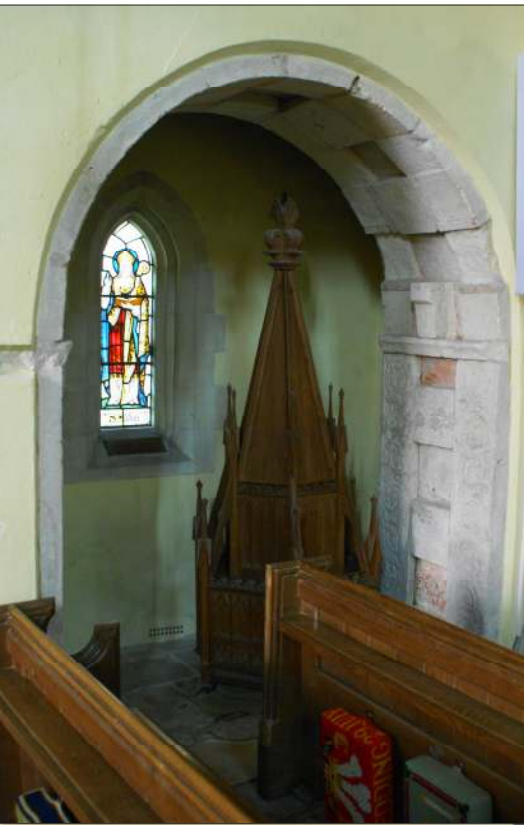
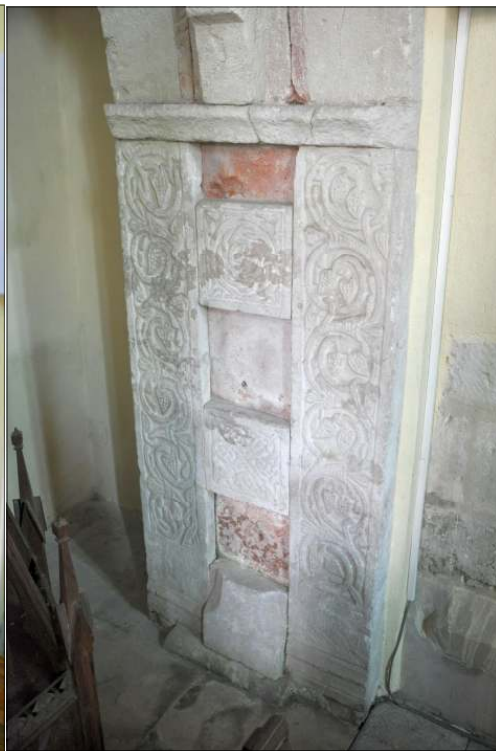
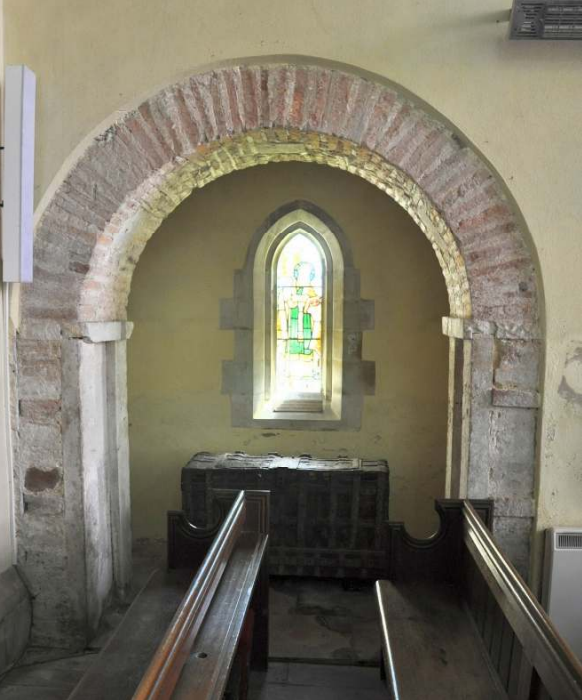
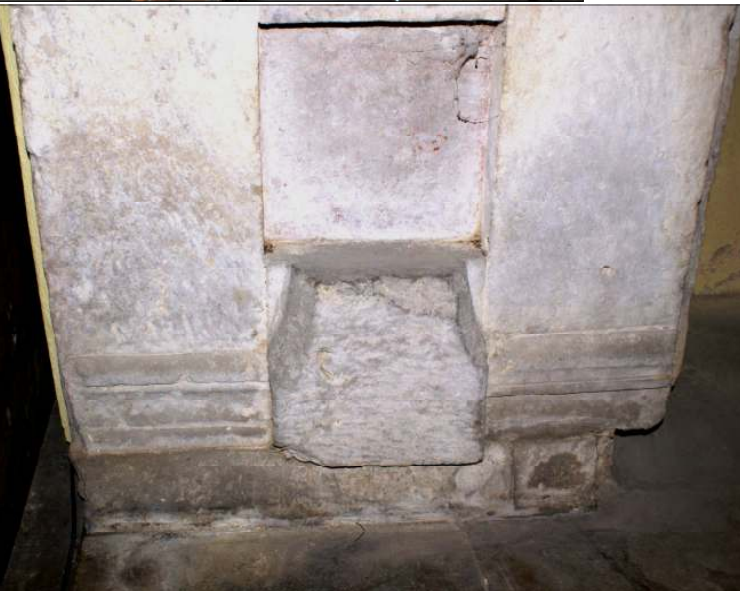
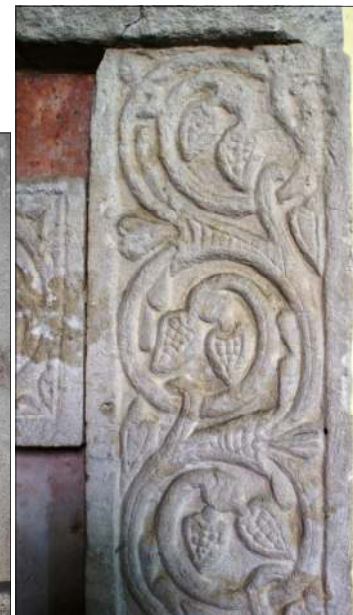
Pictures viewed clockwise from top left.

1. North archway.
2. East jamb of same; note that the vertical stones are in one piece, and this 'design' of grapes, or a vine, is found illustrated, albeit in more elaborate form, in Prof. Banister Fletcher's book "A History of Architecture" pg 67 illus. F. under the heading "Roman Ornament. 1."
3. Detail of Roman mouldings of the east jamb (southernmost of the pair). Note this stone has been shortened/sawn at the top, to 'fit' its new site, or perhaps both vertical stones were one and were

sawn in two? Taylor gives both stones as being 4ft 1in high and 8 inches wide.

4. A detail of impost of north arch and its make up. Above the impost is an undecorated (unfinished?) animal head.
5. Base of the west jamb of the north archway, note the Roman mouldings, used like a skirting board; they are common to both jambs.
6. South archway, which comprises a far higher Roman tile content than stone 'tile'.

The arches are comprised, in my opinion, in the greater part of reused Roman pieces of stone, stone 'tiles', and tiles, put together as if in some weird jigsaw. The base mouldings especially are pure Roman. I will post more information on these arches on another (text) page.

It is as if the builder has been presented with a pile of stone and asked to make two archways. Its not a bad job considering and the result of full of interest! Both these archways, on both faces were originally outlined with traditional square pilaster strips but are now much cut away; importantly parts remain.

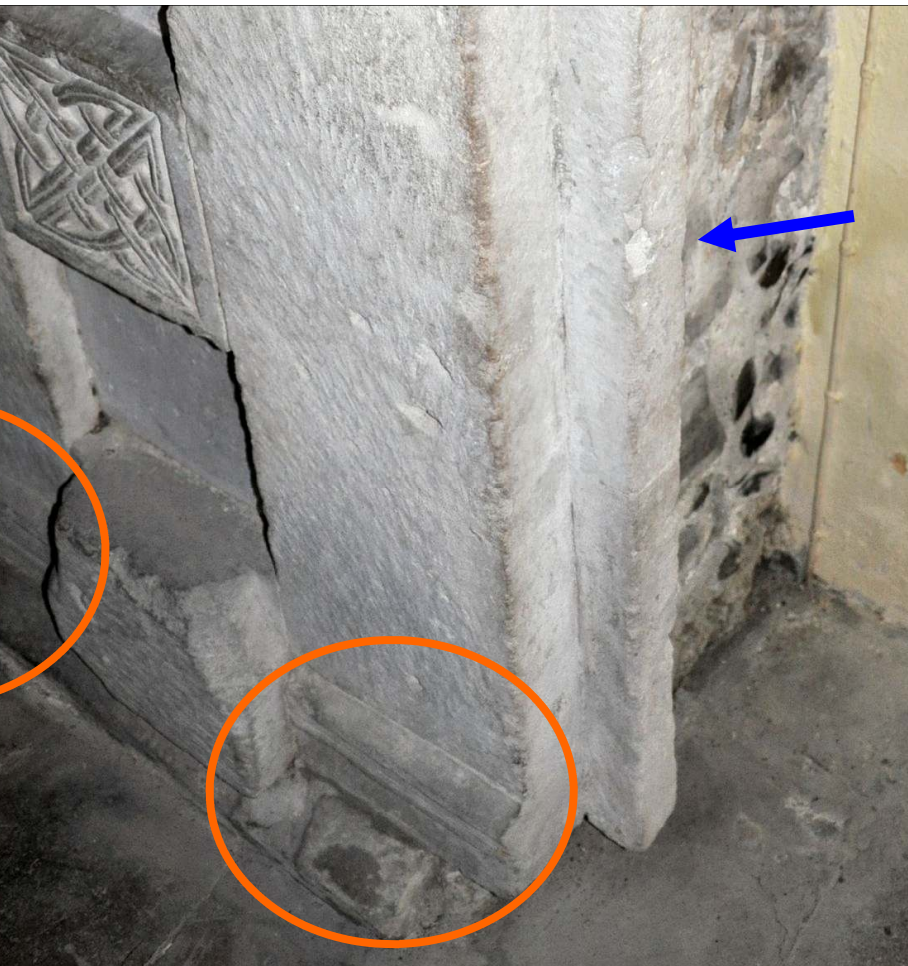
7. Here the west jamb of the north archway; the base mouldings (ringed in orange) are mentioned on page 1. They repeat on the east jamb. H. Taylor described them as being more like a skirting board, they are patently not Saxon, the vertical stones appear to be reused Roman. But, here on the north face, you will see a traditional square section pilaster strip (blue arrow).

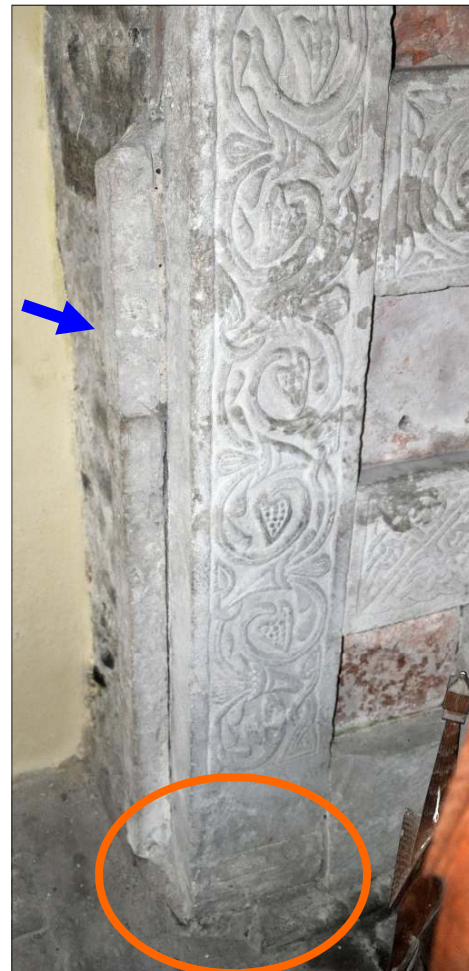
8. On the east jamb the Roman moulding seen again, ringed in orange. Note the decorated Roman stone occurs on both 'edges' on the east jamb but the uprights on picture 1 of the west jamb are plain. Perhaps the builders simply didn't have enough decorated stone? Note the square decorated tiles used quite separately. Blue arrow shows the pilaster strip.

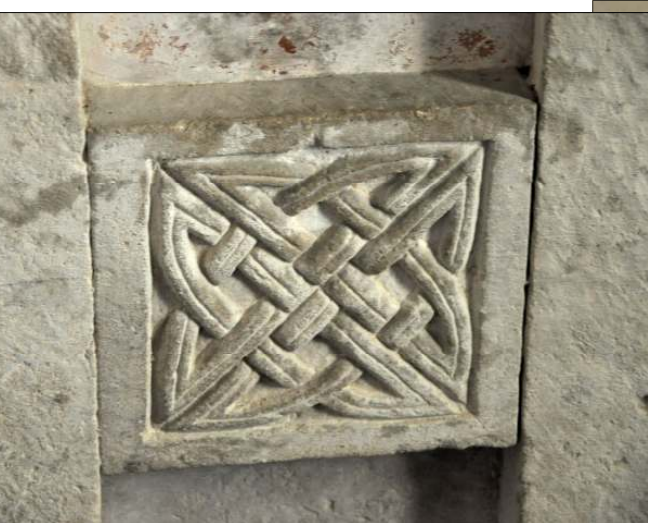
9. Looking at the north side of the east jambs with the archway springing from the abacus, note the square section pilaster strip running up from the blue arrow, it has simply been cut off below this point. Note the 'undecorated, or un-sculptured' head sitting at the centre above the abacus (red circle).

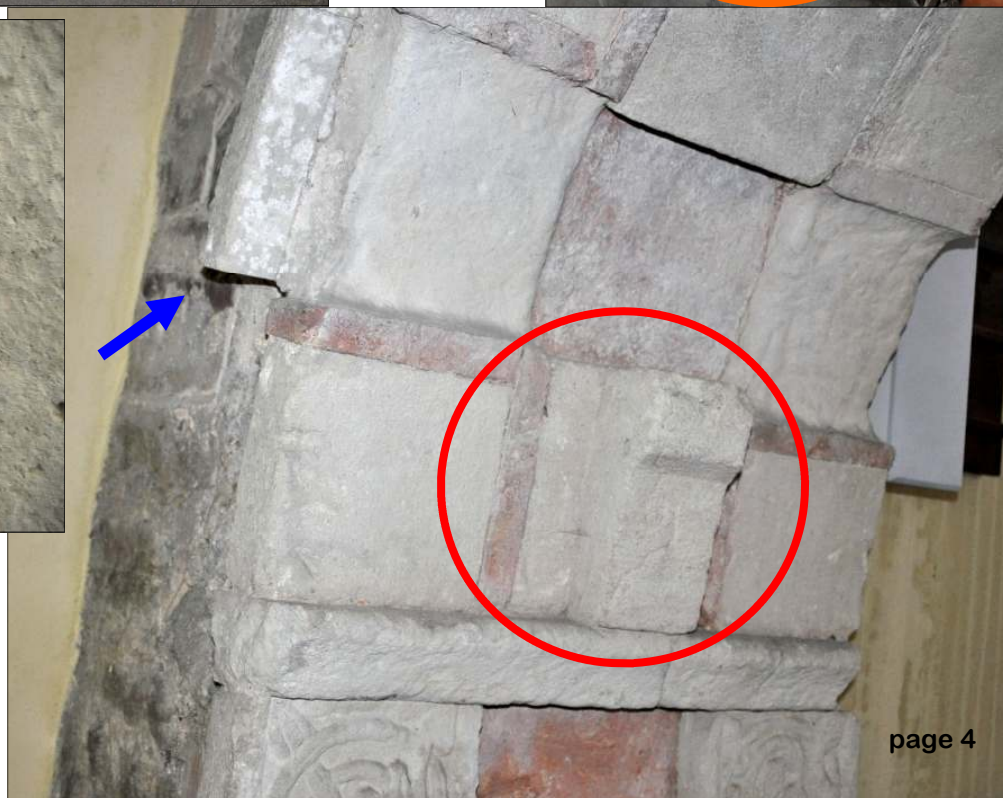
Picture 10 is described on page 5.

10. Previous page, a decorated stone seen in more detail, seen in its position in pic 7. It is finely decorated in an intertwined strap work design.

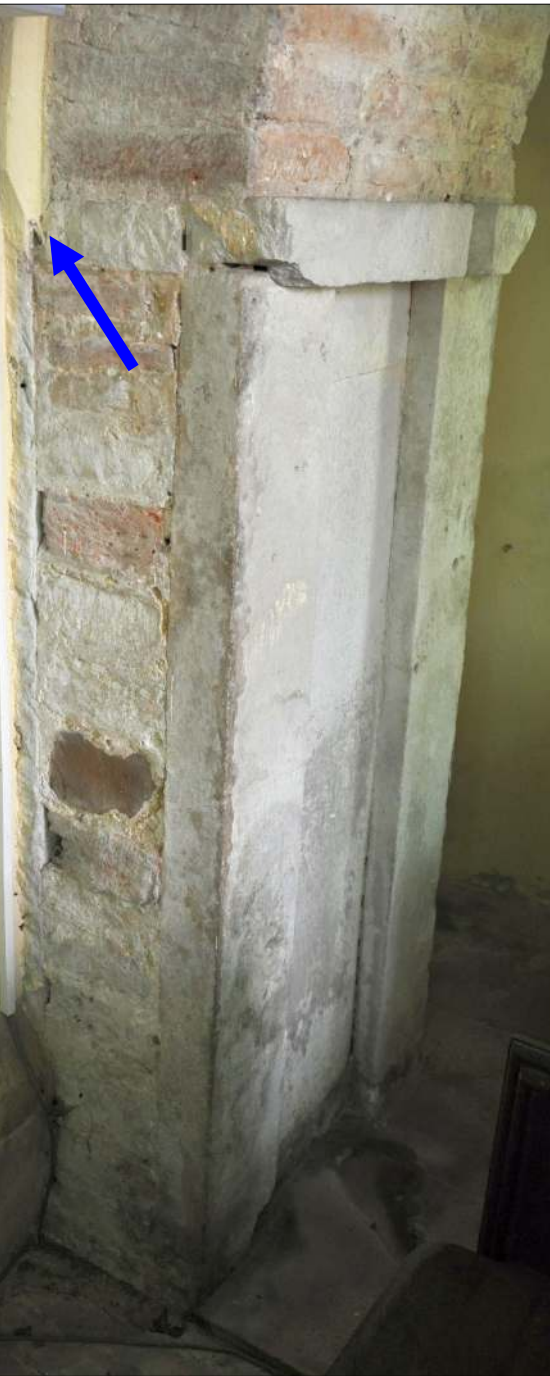
11. The south archway (top left this page) has a very different treatment that sets it apart from the north archway. This is the east jamb seen from the nave (north face). Picked out by the blue arrow is the remains of the easterly pilaster strip which is hacked away below the arrow. The impost also is hacked away on its north face. See how the east jamb uprights are 'notched' into the impost (timber technique). And see the coloured drawing illustrating this, where the jamb is in blue the impost in red, and the nave walling behind the impost is green. Observing picture 11, the jamb construction is similar to the north archway but importantly all the uprights are plain and devoid of detail, and the central part which is set back in a similar manner to its sister is devoid of decorated tiles. Compare this to picture 1. The impost is not chamfered but is a square plain section. The archway is constructed wholly of Roman bricks, yet its sister uses stone where each has been carefully shaped to a radius.

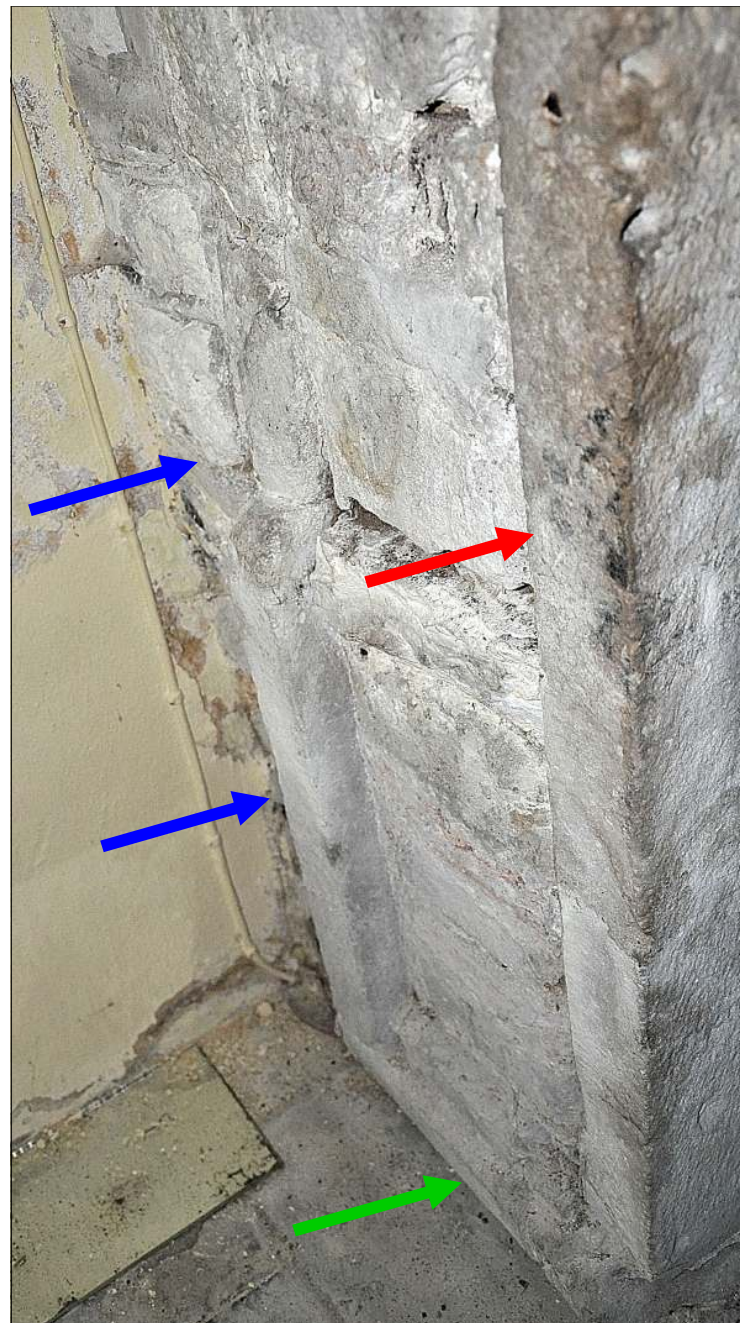
12. This shows the west jamb viewed from the south (not easy to photograph as the 19th century annexe built to protect the then newly opened archways is tiny). The blue arrows indicate the square pilaster strip and the red arrow where the jamb protrudes in a vertical plane thus in itself making a pilaster strip. The whole 'assembly' sits on a protruding plinth (green arrow).
