Church of St Mary, Deerhurst, Gloucestershire (and also Odda's Chapel of the Holy Trinity, which see page 5).

Oddas Chapel.

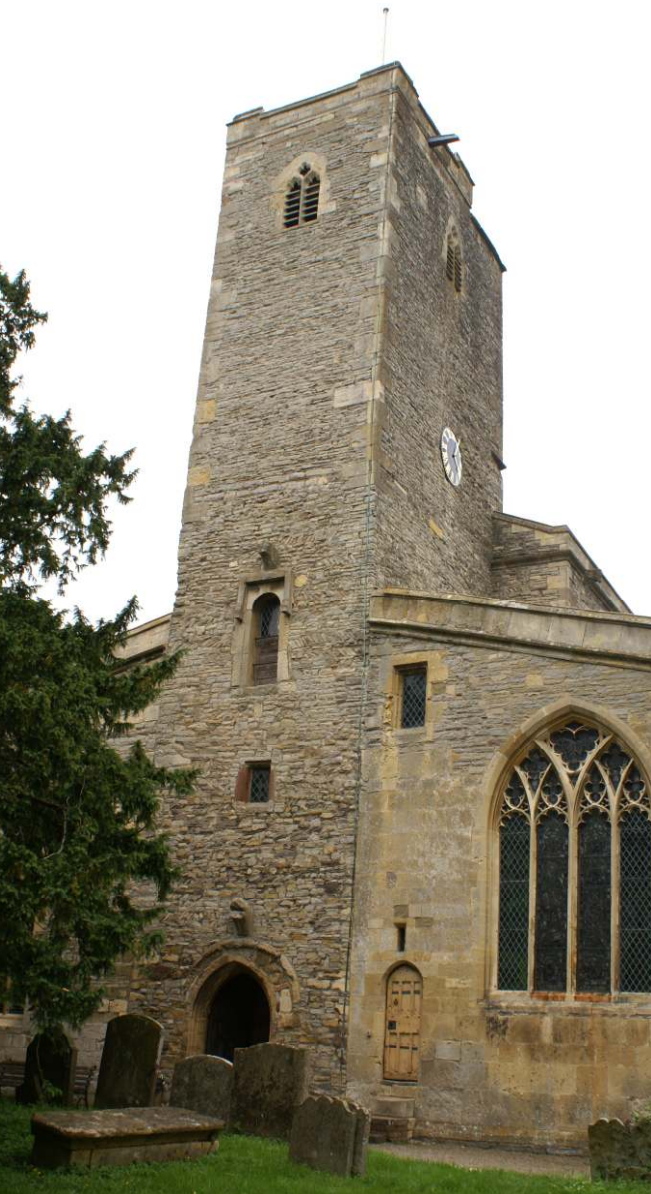
1. West tower, from W.
2. Upper stages of tower from W.
3. W doorway, situate west face of tower. The present doorway is medieval and sits inside the A-Saxon doorway, see the original hood-mould and the carved beast above.

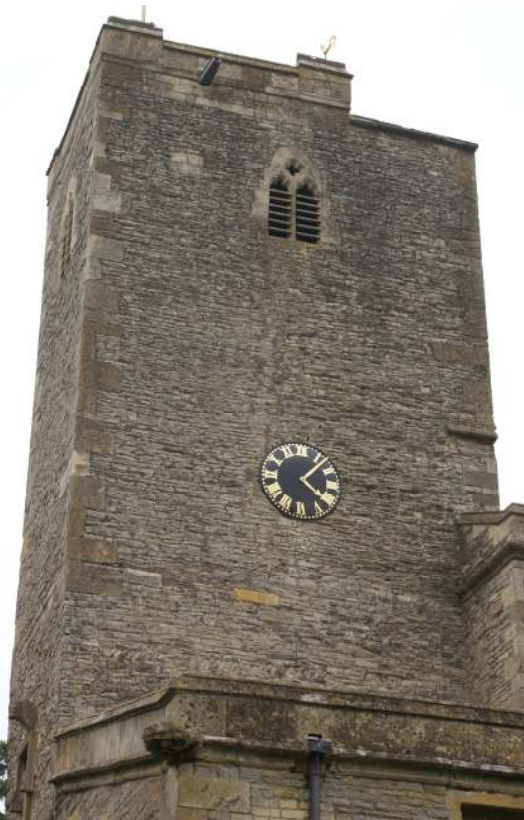
4. Western tower, south face.

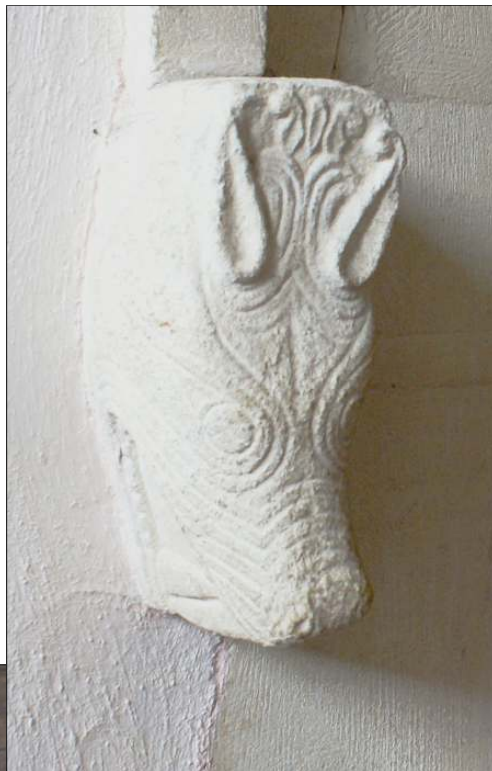
5. Animal head as label stop, internal doorway, gnd floor, tower.

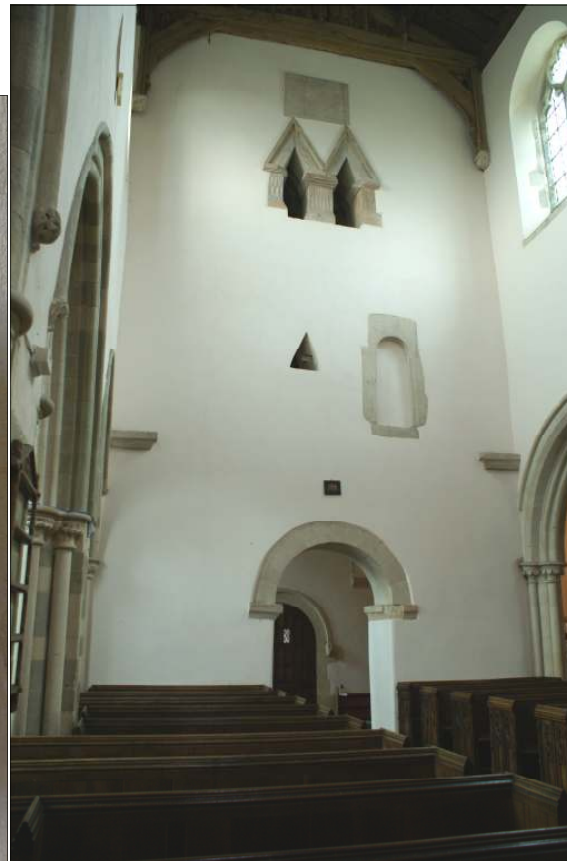
6. Looking towards the west, in nave, showing east face of tower with archways etc.

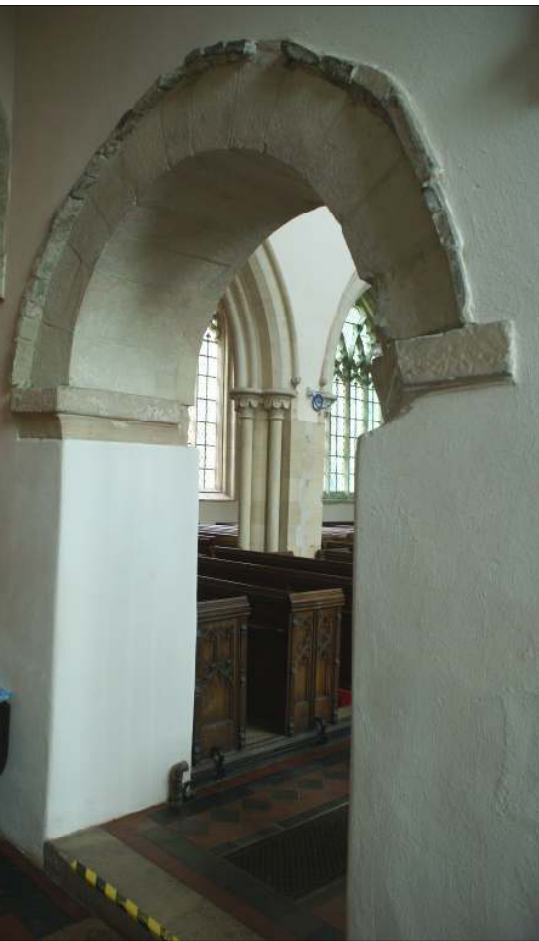
9. Ground floor archway in east face of tower wall, seen from inside the tower, thus its west face seen from the SW.

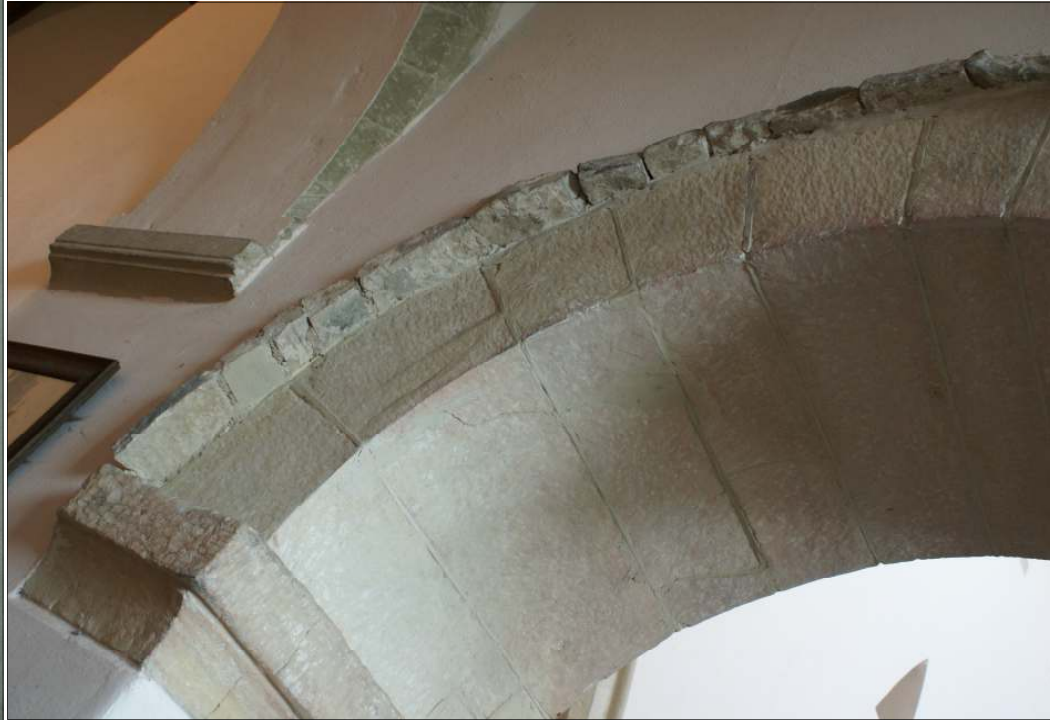
10. A part of the archway, a close-up view, same aspect.

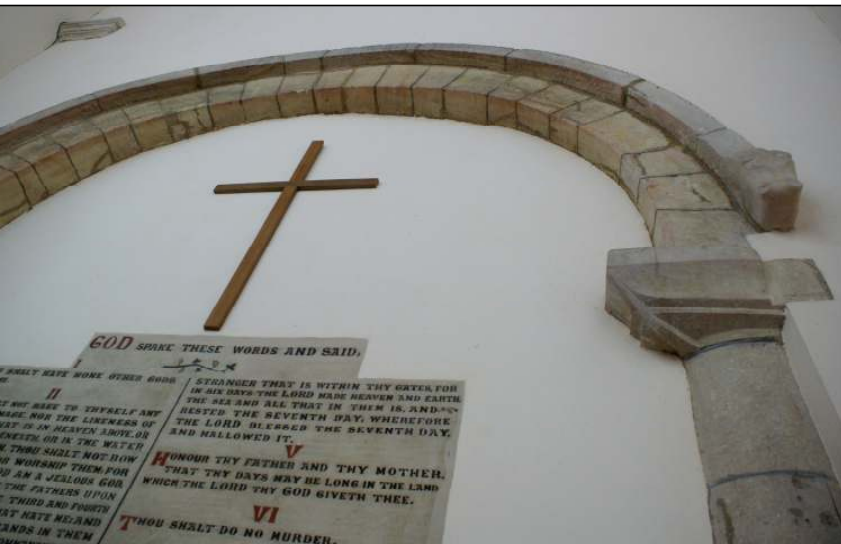
13. The remarkable chancel arch seen from the nave, including the southern capital.

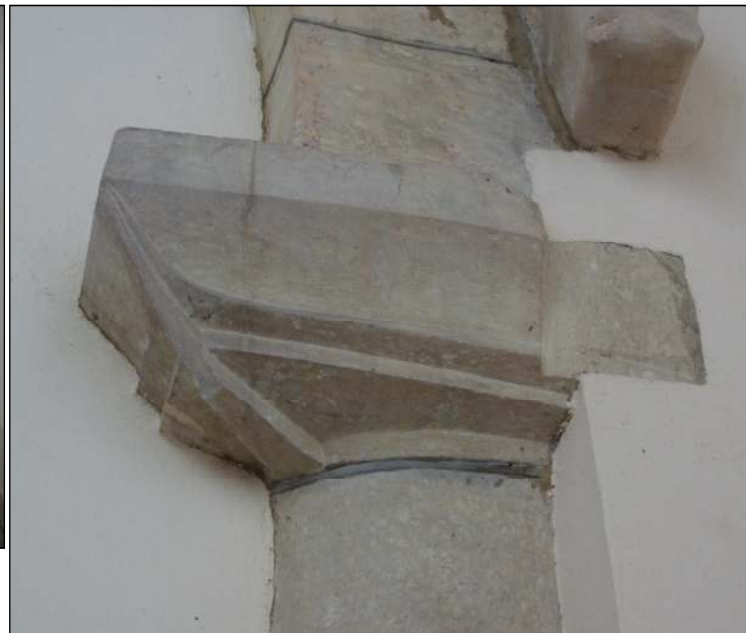
14. The S capital in detail.

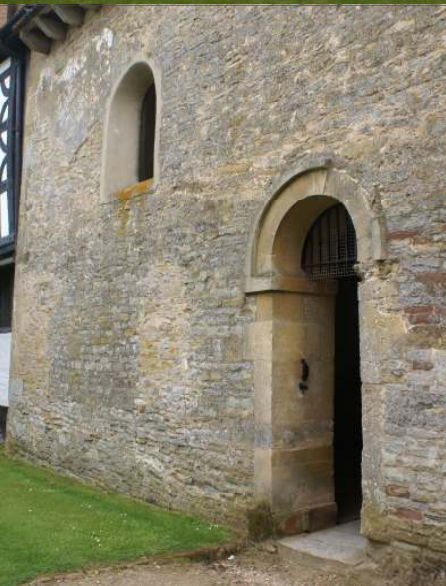
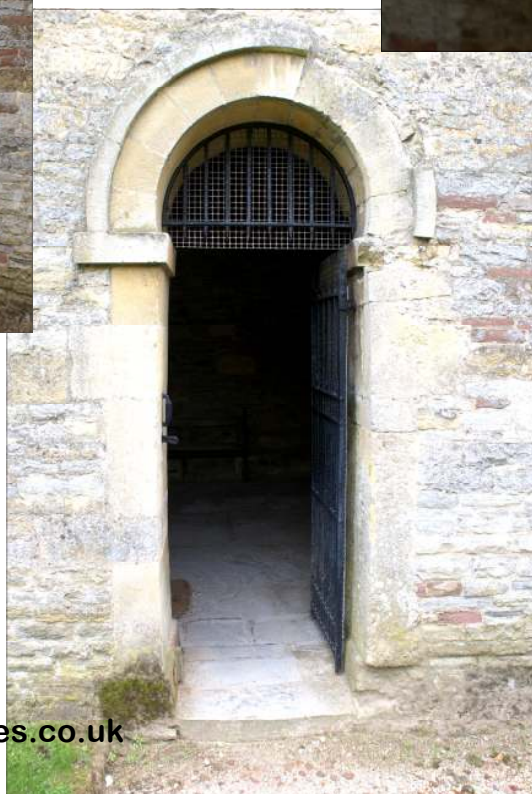
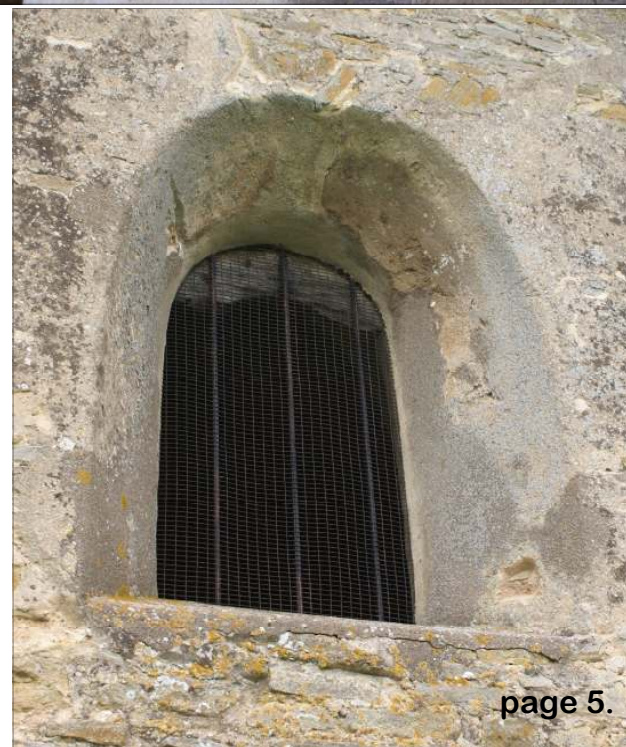
17. The chapel from the SW. 2. The chancel arch from the nave. 3. The S capital of the chancel arch.
18. Double splayed window in N wall nave, seen from outside; this window has remains of the oak frame in situ.
19. Doorway, N wall nave.
20. The doorway and window in N wall of nave.
