This picture file covers chancel, tower & crossing arches, doorways, stairways, and detail.

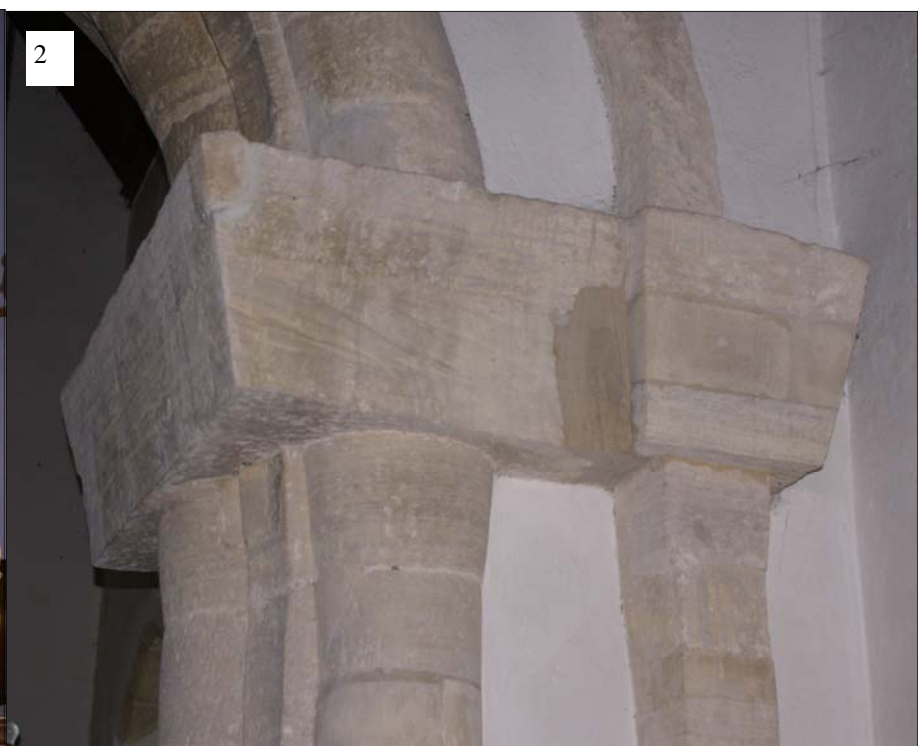
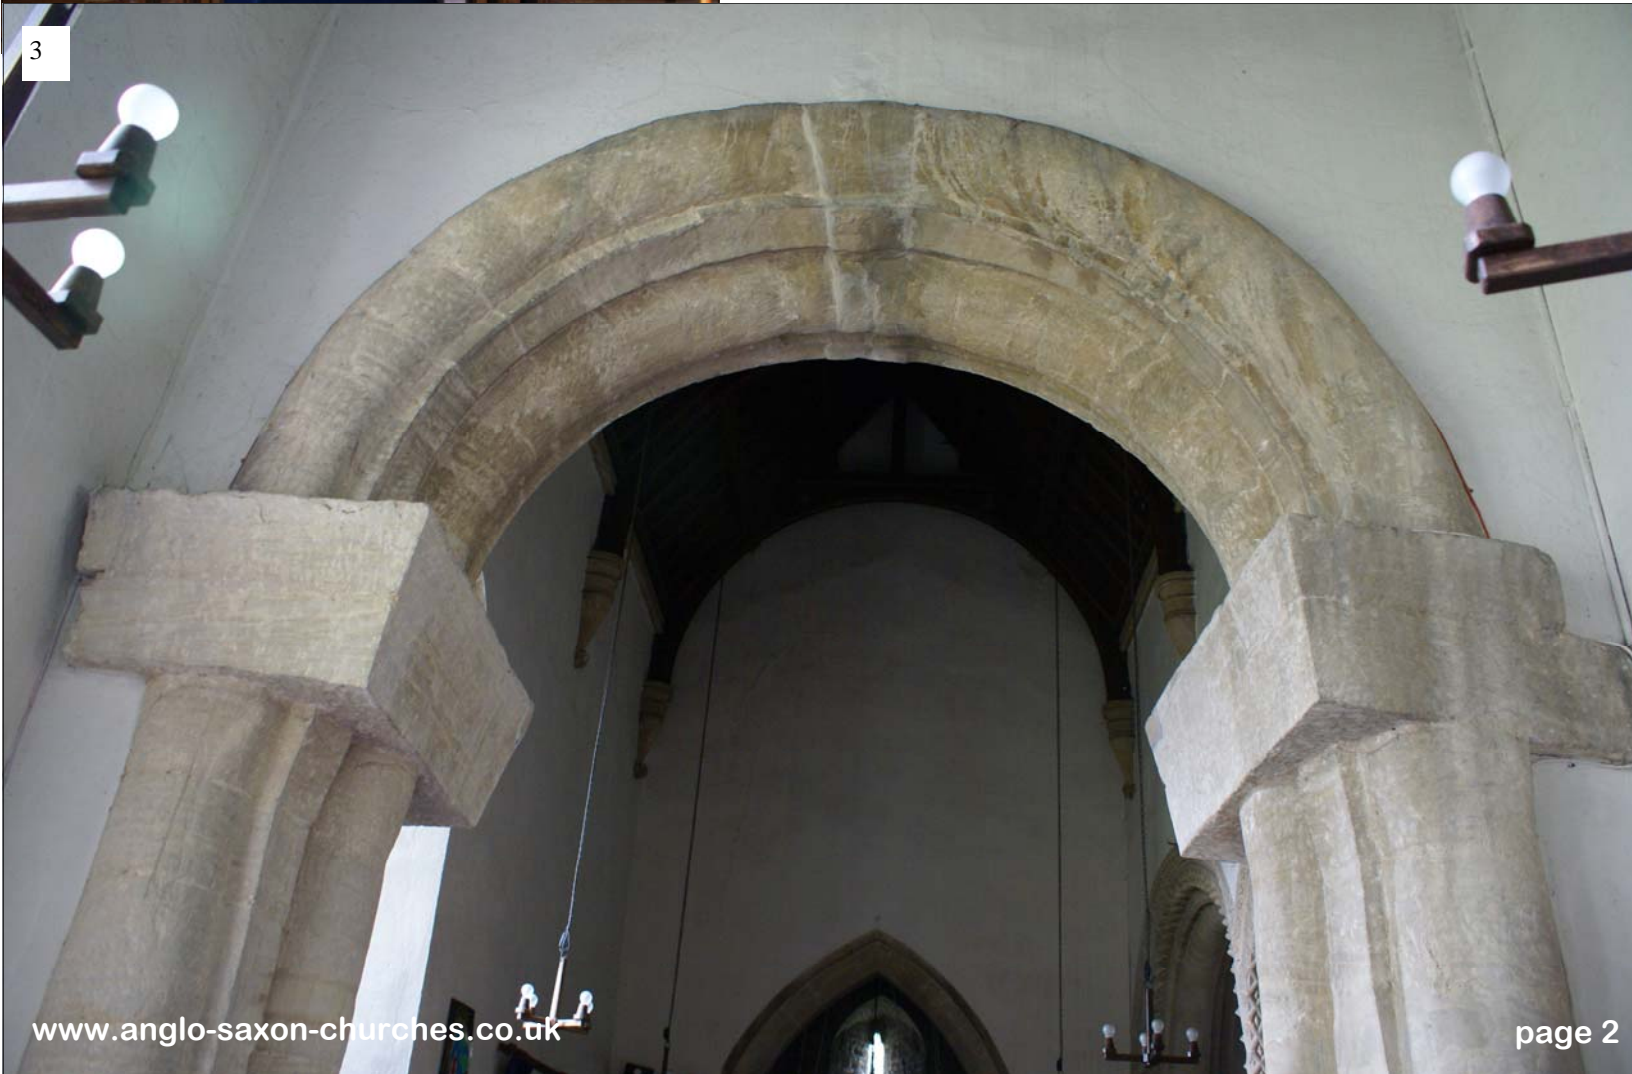
All Saints church, Wittering, Northants.

1. Chancel arch from west.
2. South impost and springing of arch, and showing 'outer pilaster in square section.
3. Chancel arch viewed from the chancel.

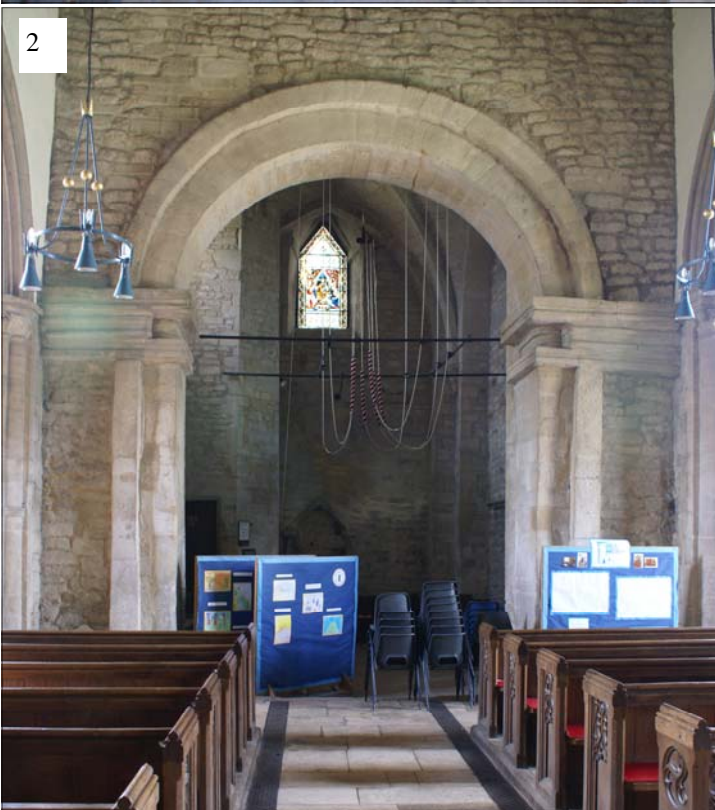
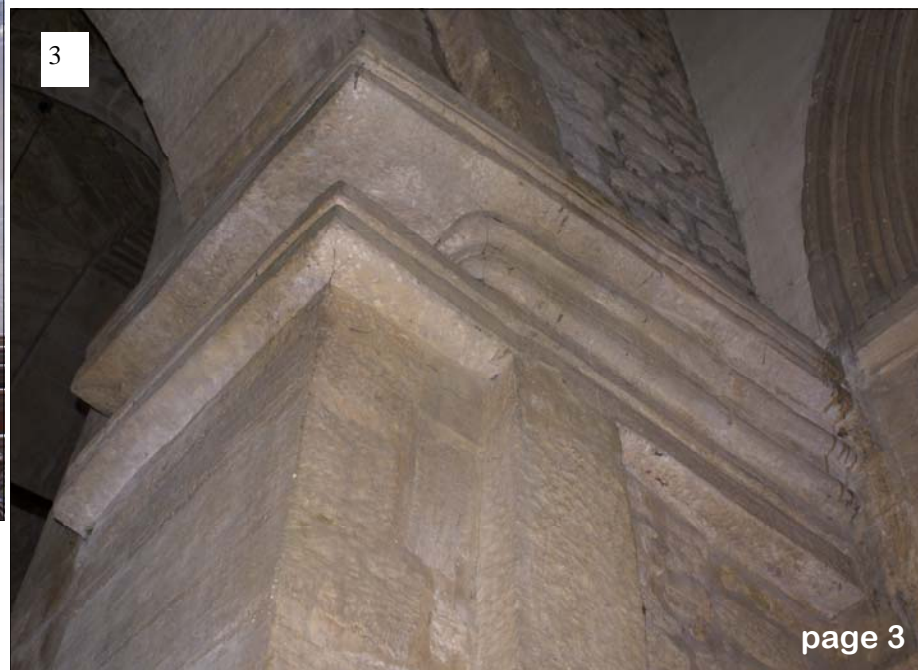
Church of St. John, Barnack, Cambridgeshire.

1. Tower archway showing curious 'sandwich' type construction of (north) impost.
2. The archway viewed from the nave.
3. As picture 1, but viewed from a different (lower) angle.

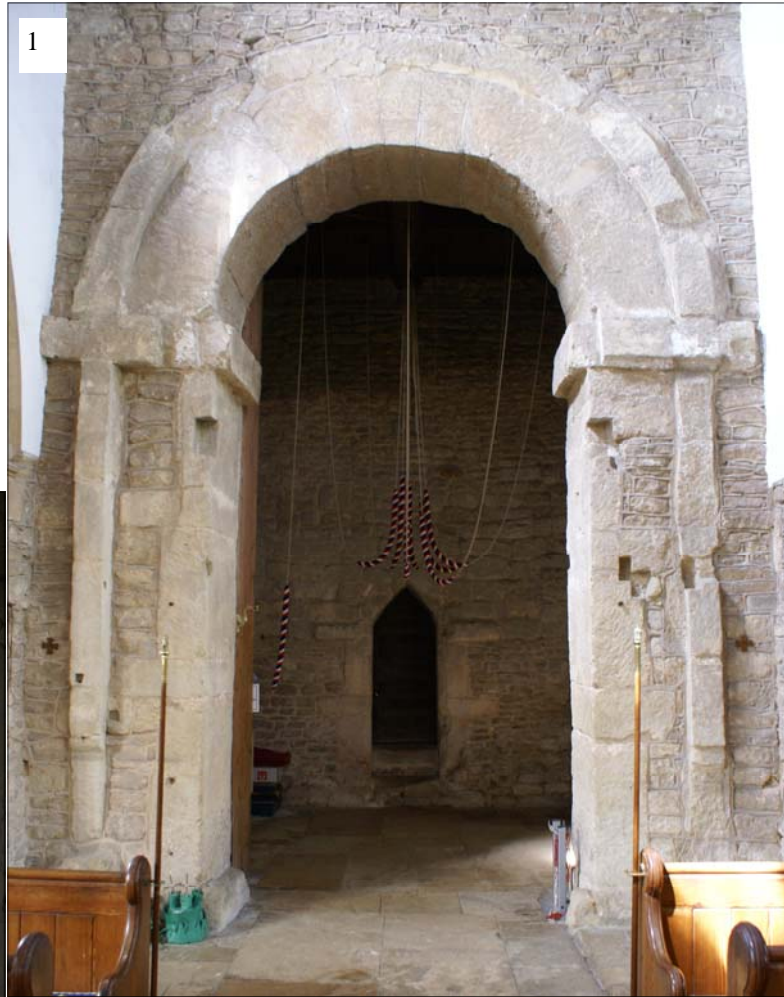
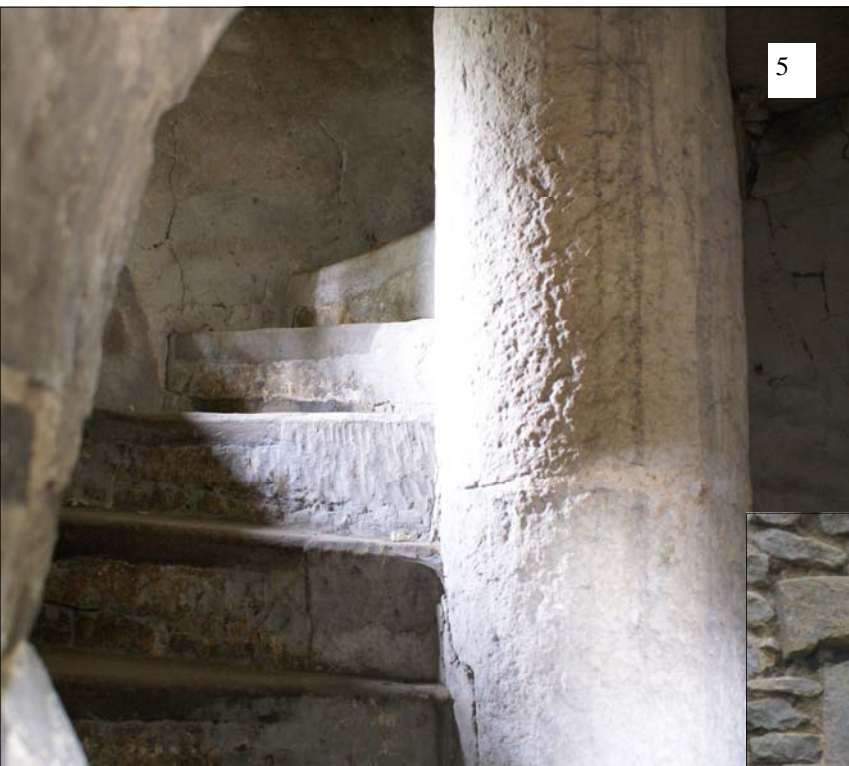
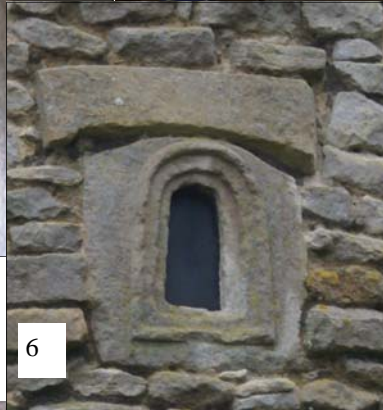
Church of St. Andrew, Brigstock, Northants.

1. Tower archway viewed from nave.
2. The detail of the pilaster on south side of that arch.
3. Doorway, triangular headed, leading from tower to stairway.
