## 10<sup>th</sup> century ecclesiastical fabric in northern France and the influence of continental practices upon Anglo-Saxon fabric and styles in England.

### **Jumièges Abbey, northern France.**

#### Openings with mid-wall shafts supporting through-stones.

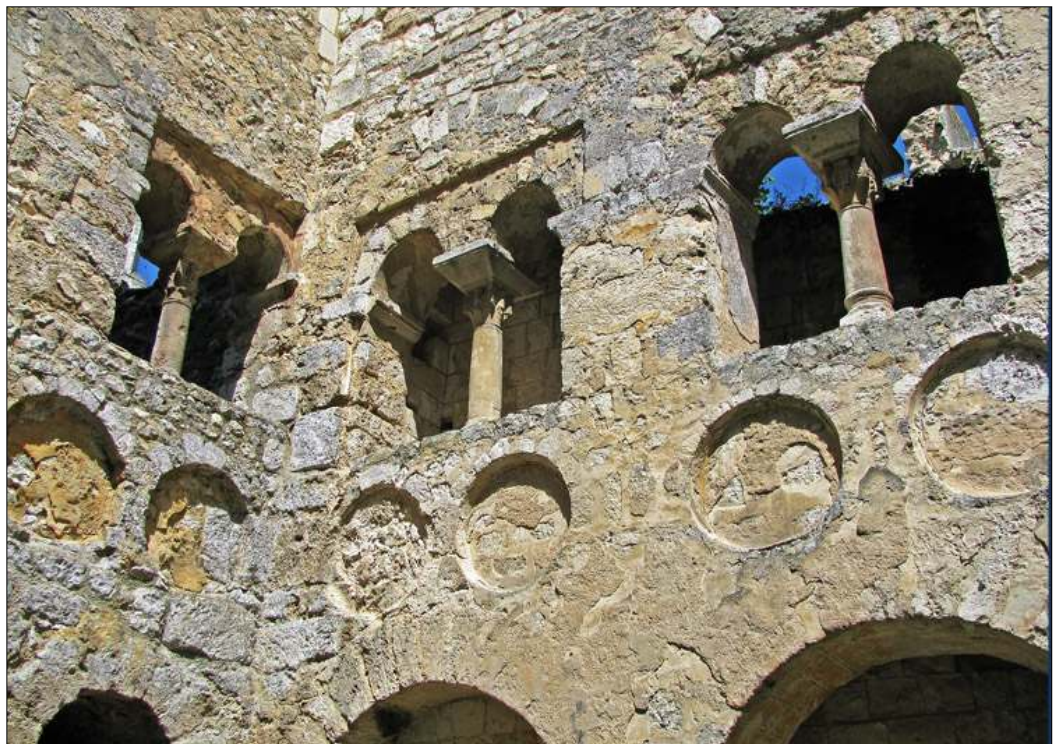
Commencing in 942 the Abbey church at **Jumièges** in northern France, was rebuilt after the Viking invasions resulted in the fabric standing in ruins. There are some really nice openings (see photo below), which I calculate date from the rebuilding at this time since they cannot belong to the next rebuilding in the 11th century (which would be in the Romanesque style). The technique is identical with the English Anglo-Saxon where the arched openings are formed of stones making an opening with jambs straight through the depth of the wall and with distinctive mid-wall shaft supporting the arch on a through-stone. The existence of this type of opening in England doubtless represents knowledge from the continent being imparted to English masons, who were being schooled abroad, and returning to their homeland where they in turn schooled those under them.
